DEPARTMENT OF TRANSPORTATION  
Structure Maintenance & Investigations

Bridge Number : 24C0004  
Facility Carried: DILLARD RD  
Location : 0.2 MI S OF S.R. 16  
City :  
Inspection Date : 04/29/2010

## Bridge Inspection Report

STRUCTURE NAME: COSUMNES RIVER

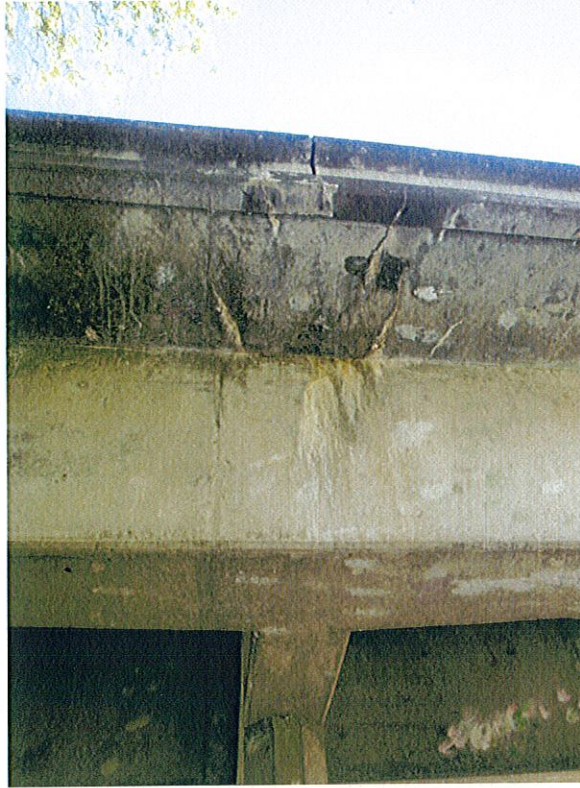
Photo No. 1

There are transverse cracks located in both the right and left overhangs at each pier. These cracks have light efflorescence and are spaced between 6"-12" apart. This condition is caused by negative moment bending. See attached photo.

The efflorescence indicates water is seeping through the slab and is dissolving the calcium carbonate in the cement portion of the concrete. At this time the severity and quantity of the condition listed above does not warrant corrective action.

Typical transverse overhang soffit cracks found at each pier

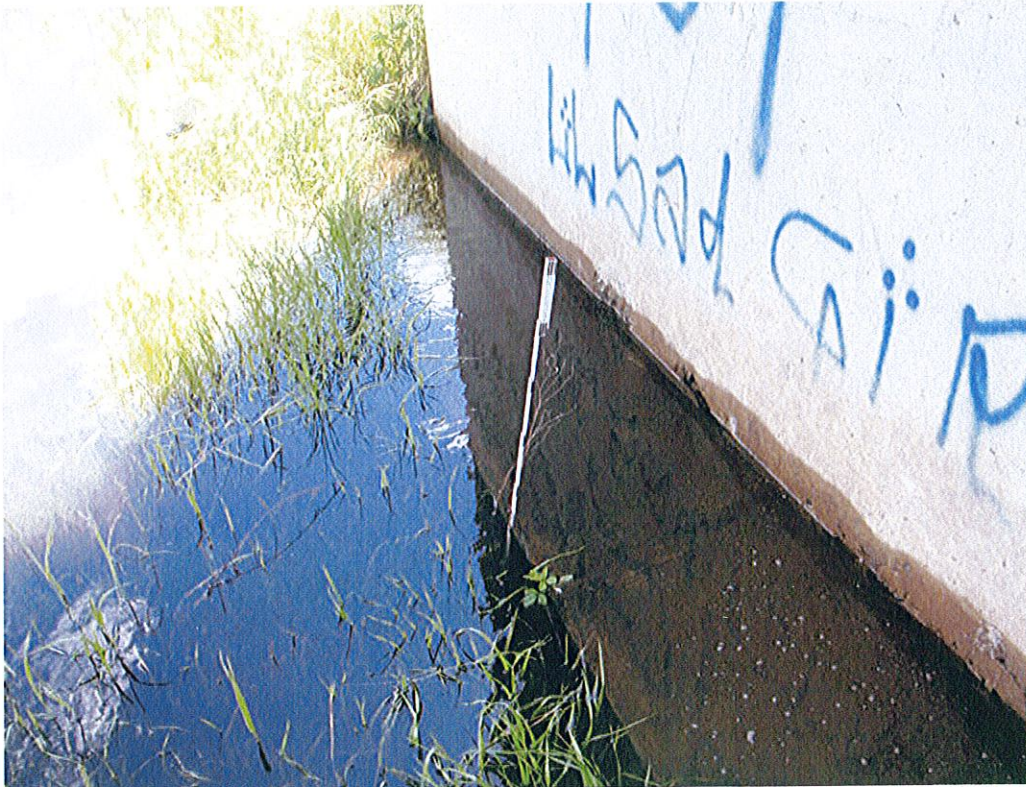
Photo No. 2

There is 1' of vertical exposure along the entire length of the Pier 2 pile cap on the Span 2 side. No undermining was observed during this inspection. This is the first documentation of scour at this location. At this time no corrective action is required; however, the local agency should monitor this location during high flow events and provide scour countermeasures as deemed necessary. See attached photo.

1' vertical expose along the entire length of the Pier 2 footing on the Span 2 side
