Bridge Number : 24C0004  
Facility Carried: DILLARD RD  
Location : 0.2 MI S OF S.R. 16  
City :  
Inspection Date : 04/18/2007

## Bridge Inspection Report

**STRUCTURE NAME:** COSUMNES RIVER

Bridge Number : 24C0004  
Facility Carried: DILLARD RD  
Location : 0.2 MI S OF S.R. 16  
City :  
Inspection Date : 10/11/2006

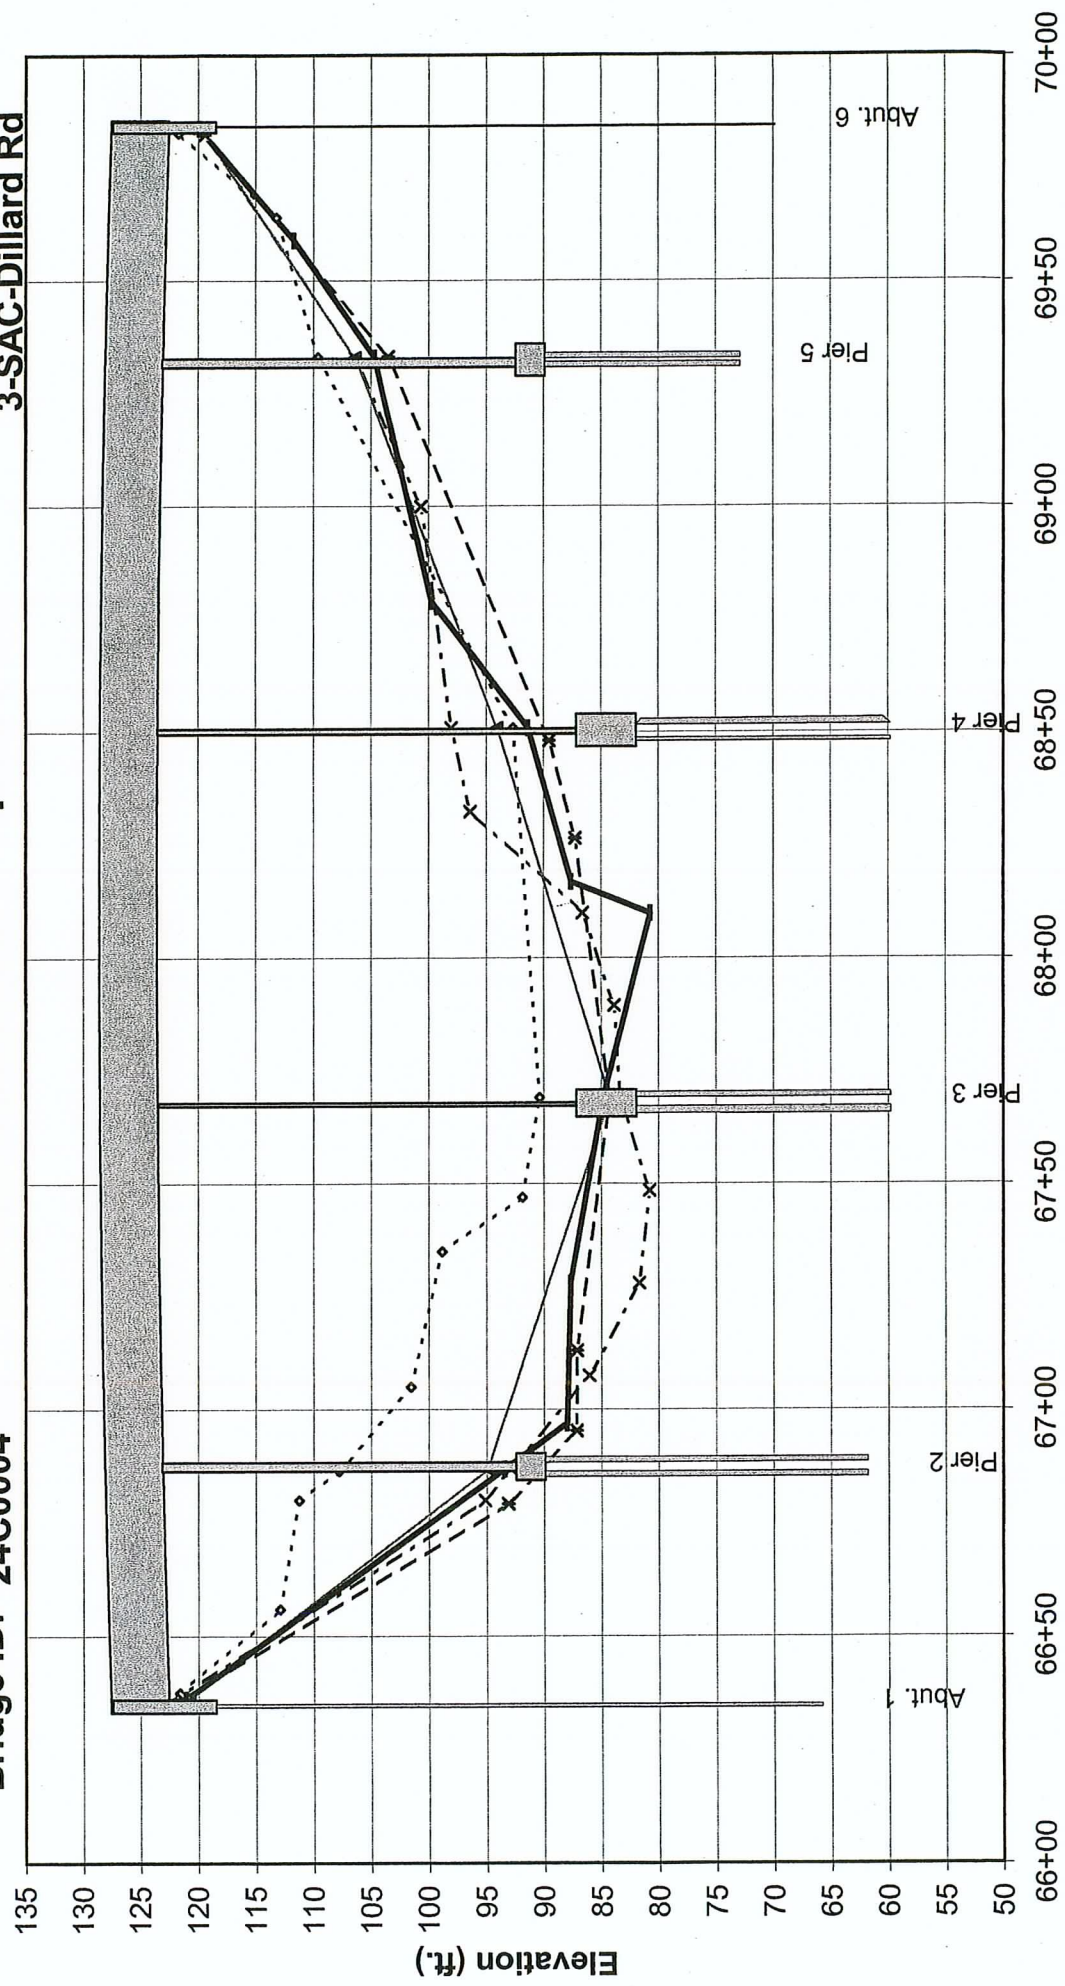
# Cosumnes River - Upstream

A comparison of the present channel cross-section with available historical channel cross-sections taken in 1972 and after shows that the channel bottom elevation (thalweg) has substantially degraded (10 ft) since the bridge was built (see attached plotted historical cross-sections at the bridge).

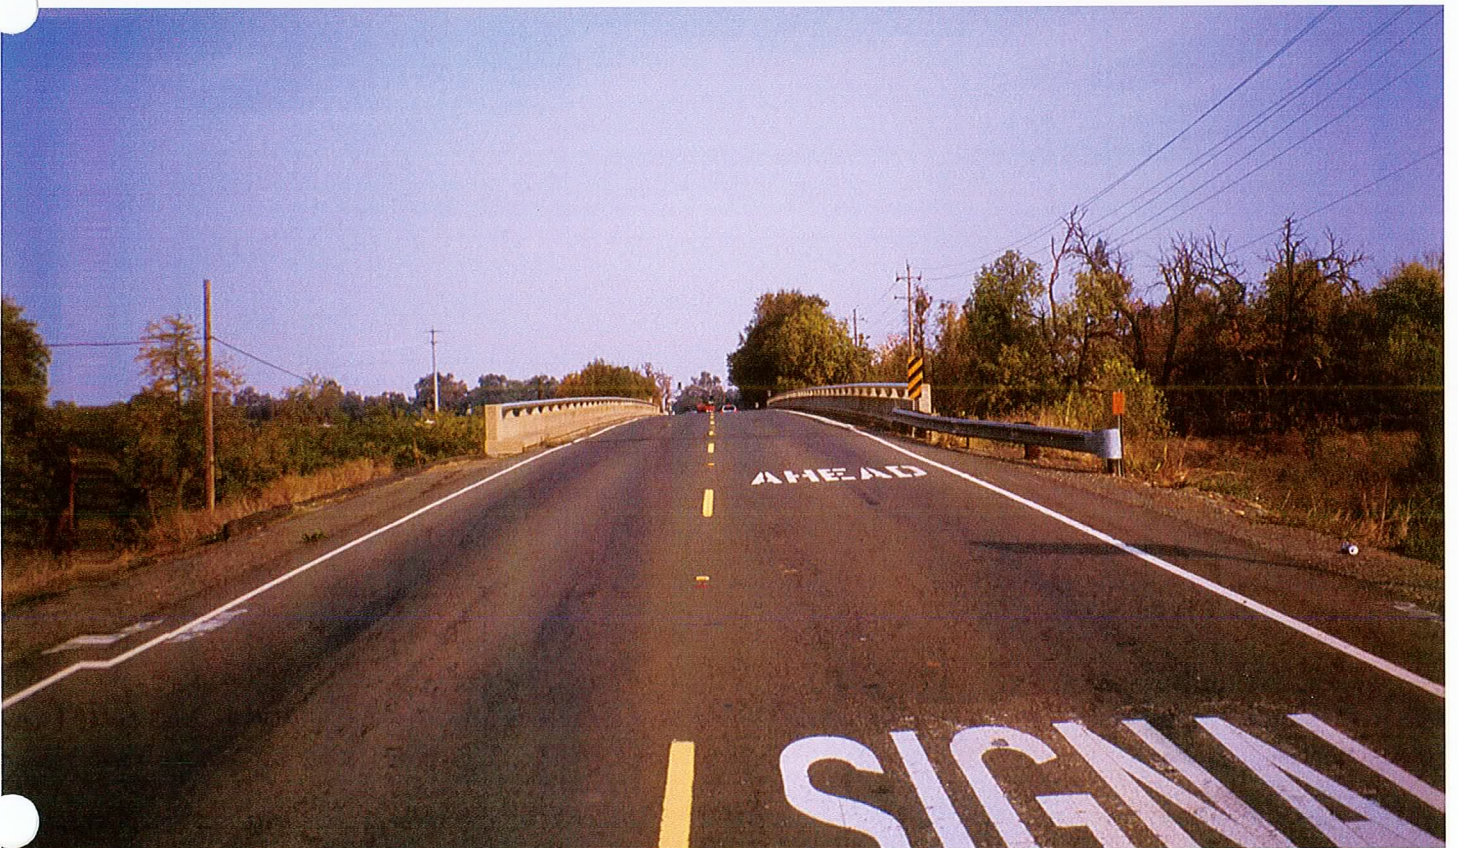
ROADWAY: Looking North  
03-Sac-Co.Rd., Br#24C0004, Cosumnes River, 11-15-01, 06B-Sac2-20

The AC surfacing is failing along the wheel lines, in several locations throughout the bridge deck.

Remove AC surfacing, and grind AC approaches to level as necessary.
