DEPARTMENT OF TRANSPORTATION  
Structure Maintenance & Investigations

Bridge Number : 24C0053  
Facility Carried: TWIN CITIES ROAD  
Location : 2.0 MI EAST OF RIVER RD  
City :  
Inspection Date : 02/10/2010

## Bridge Inspection Report

STRUCTURE NAME: SNODGRASS SLOUGH

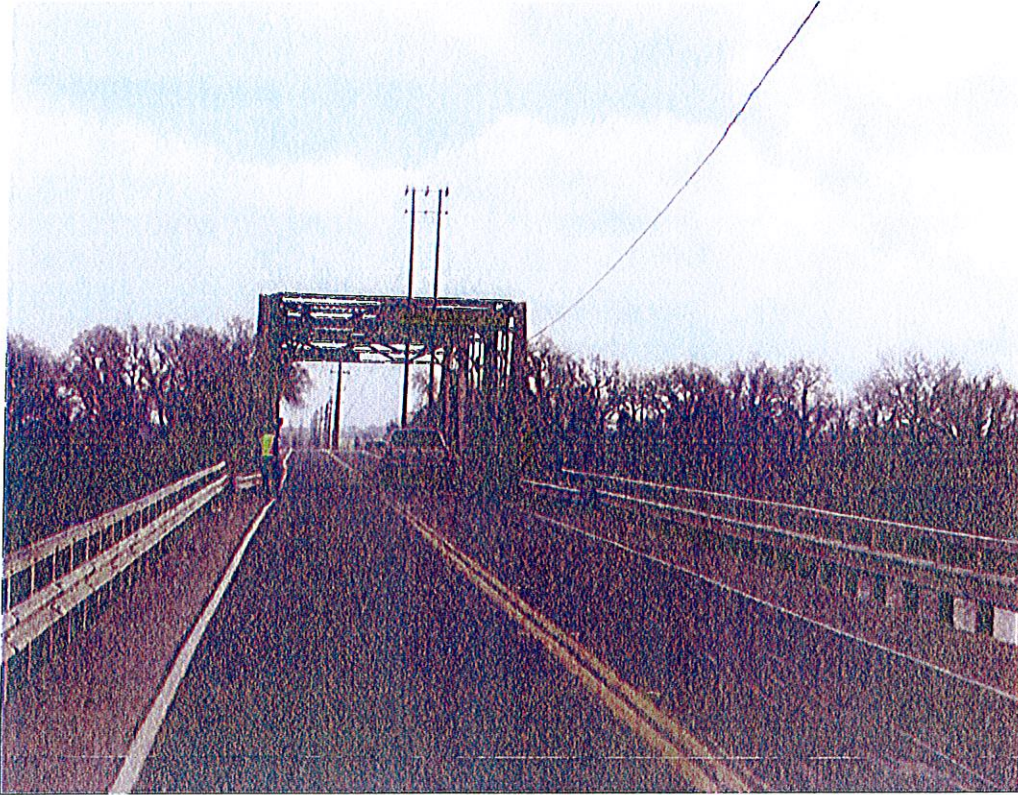
**Photo No. 1**

**Roadway view looking east.**

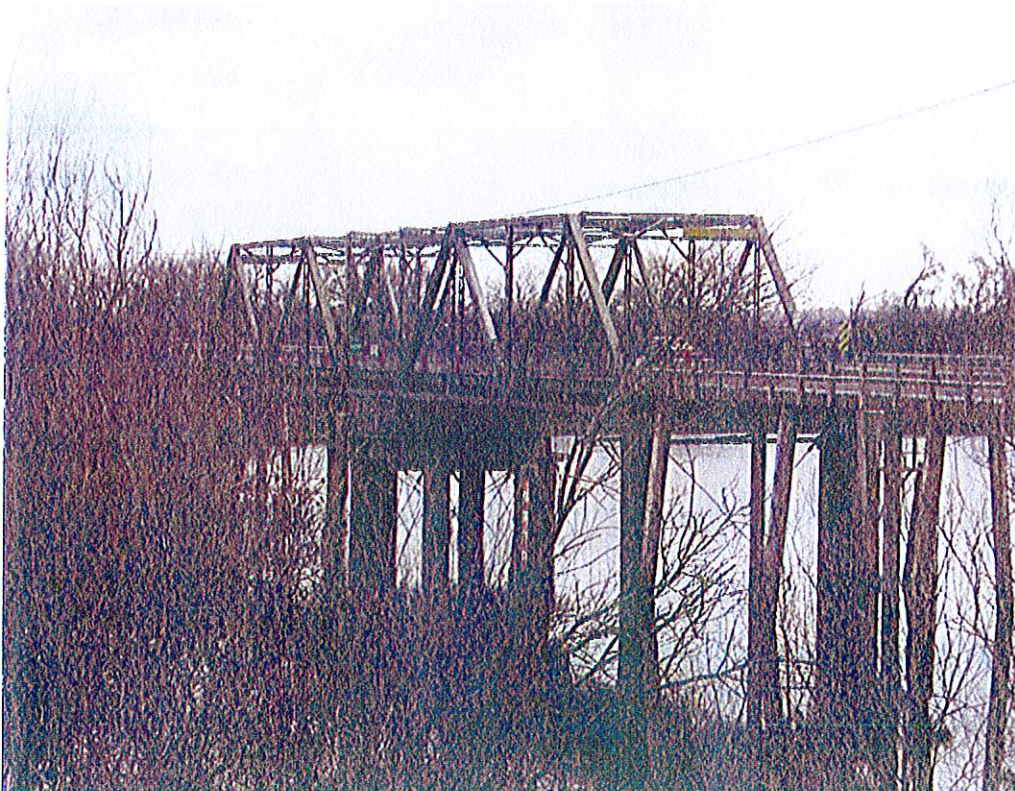
**Photo No. 2**

**Routine elevation looking southeast.**

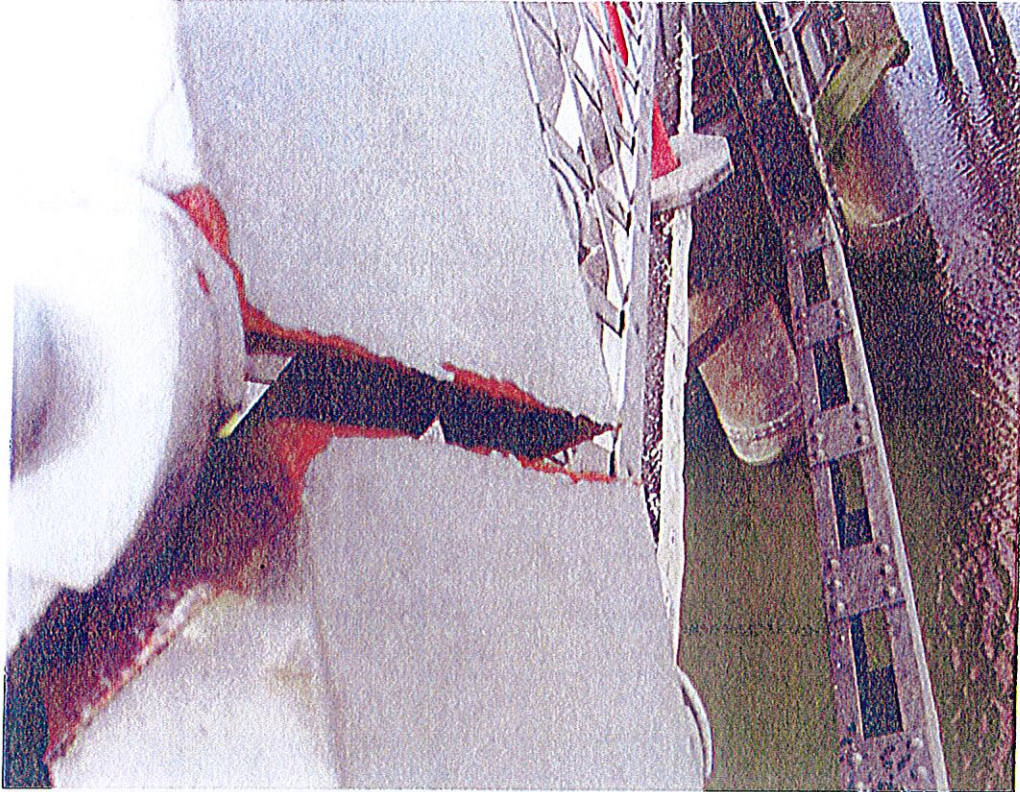
Photo No. 3

The diagonal member U6-L7 on the right side of Span 13 had been damaged in two locations by vehicular impact. The member's exterior channel had been completely fractured approximately 3' below the top of deck and there was a fracture in the interior channel approximately 3.5" long at the connection to the lower gusset plate (see Photo's 3 and 4). The damaged member has been replaced with a new steel built-up channel section diagonal member.

Complete fracture of the exterior channel of diagonal member U6-L7 in Span 13.

The corrugated steel deck has been completely replaced with a new AC overlay on the deck and approaches, new bridge rail has been installed, and fractured truss member U6-L7 (due to traffic impact) has been replaced with a new built-up truss member.

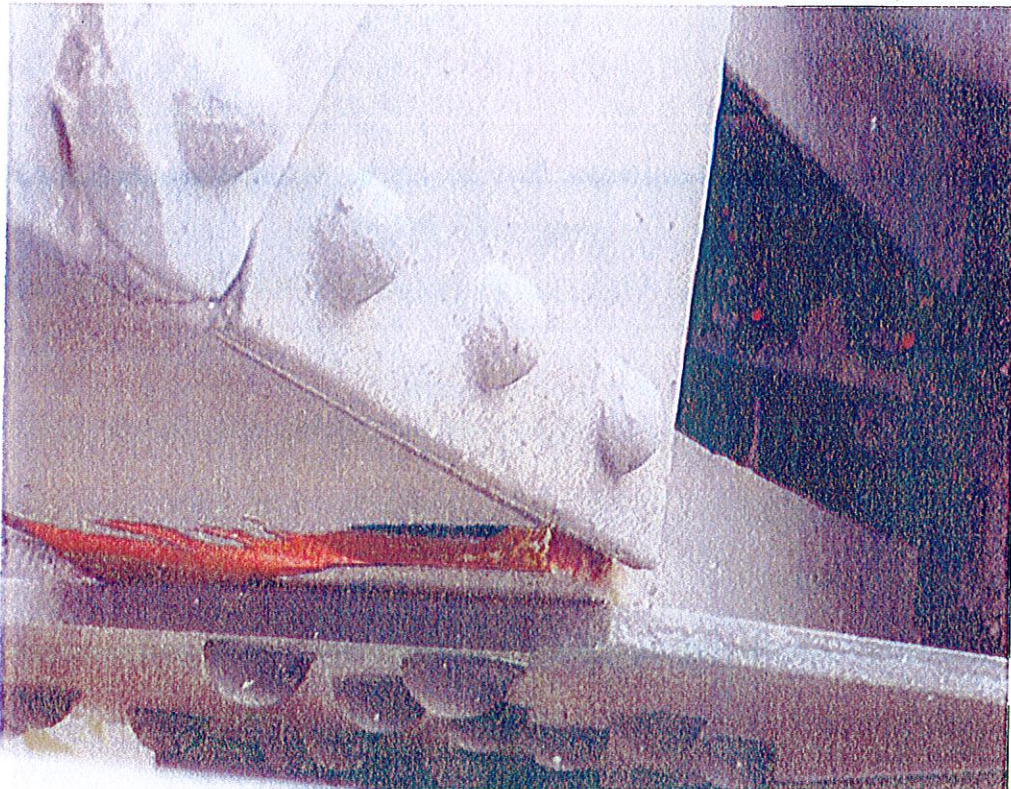
Photo No. 4

Tear in the interior channel of diagonal member U6-L7 in Span 13 at the lower gusset plate

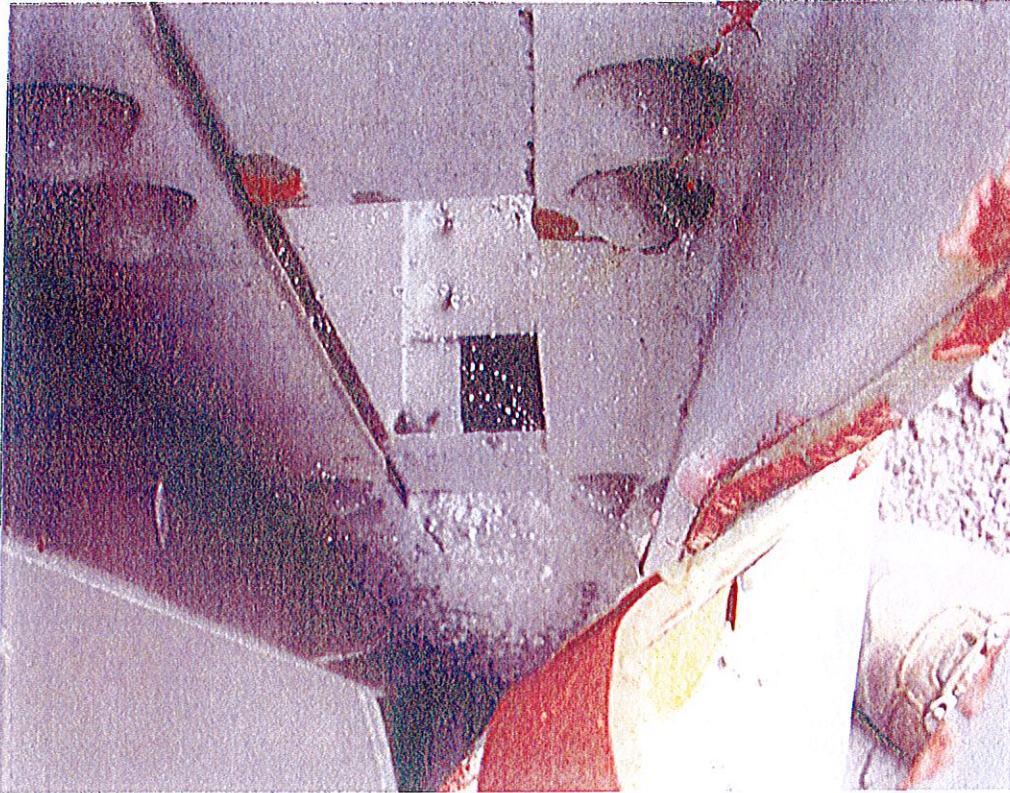
Photo No. 5

The left bridge rail in Span 10 and the 3rd vertical member (L3-U3) has been damaged by vehicular impact. Approximately 3' of the rail is bent and the vertical member's interior flange has been bent inwards approximately 2" over a length of 2 feet.

Bent flange of vertical member L3-U3 in Span 10 due to vehicular impact.

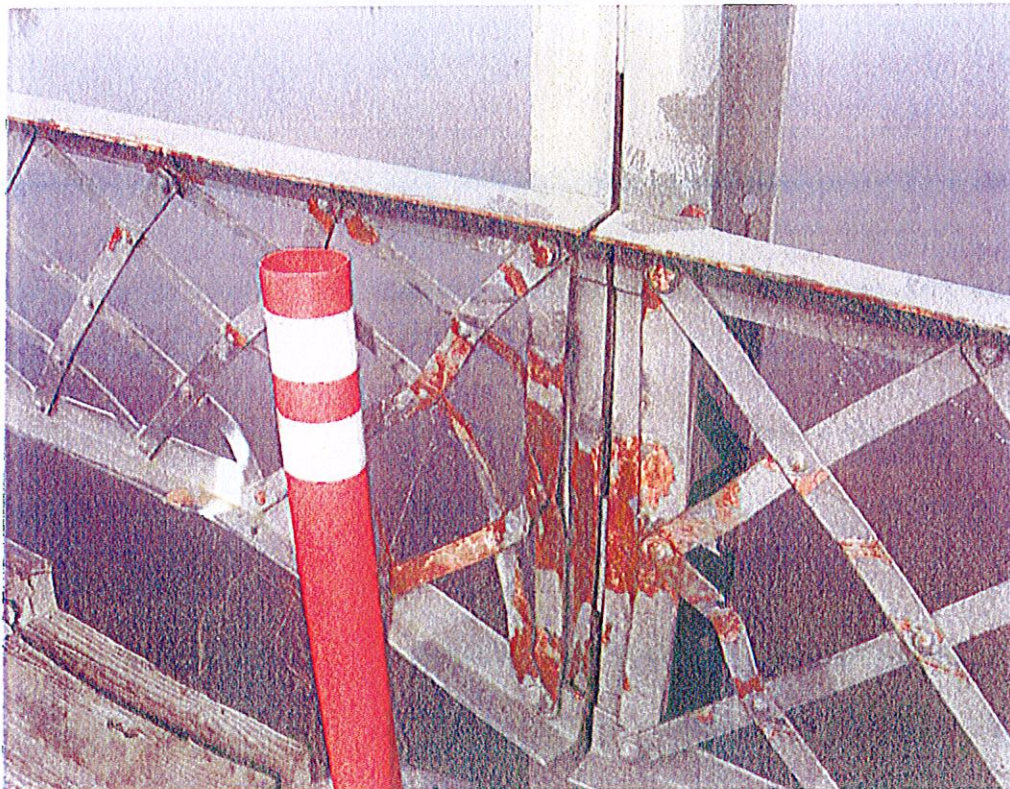
Photo No. 6

Damaged bridge rail and vertical member L3-U3 in the left truss in Span 10.
