DEPARTMENT OF TRANSPORTATION
Structure Maintenance & Investigations

Bridge Number : 24C0155
Facility Carried: FRANKLIN BLVD
Location : 1.8 MI N SAN JQUIN CO LI
City :
Inspection Date : 01/25/2007

Bridge Inspection Report

STRUCTURE NAME: MOKELUMNE RIVER OVERFLOW

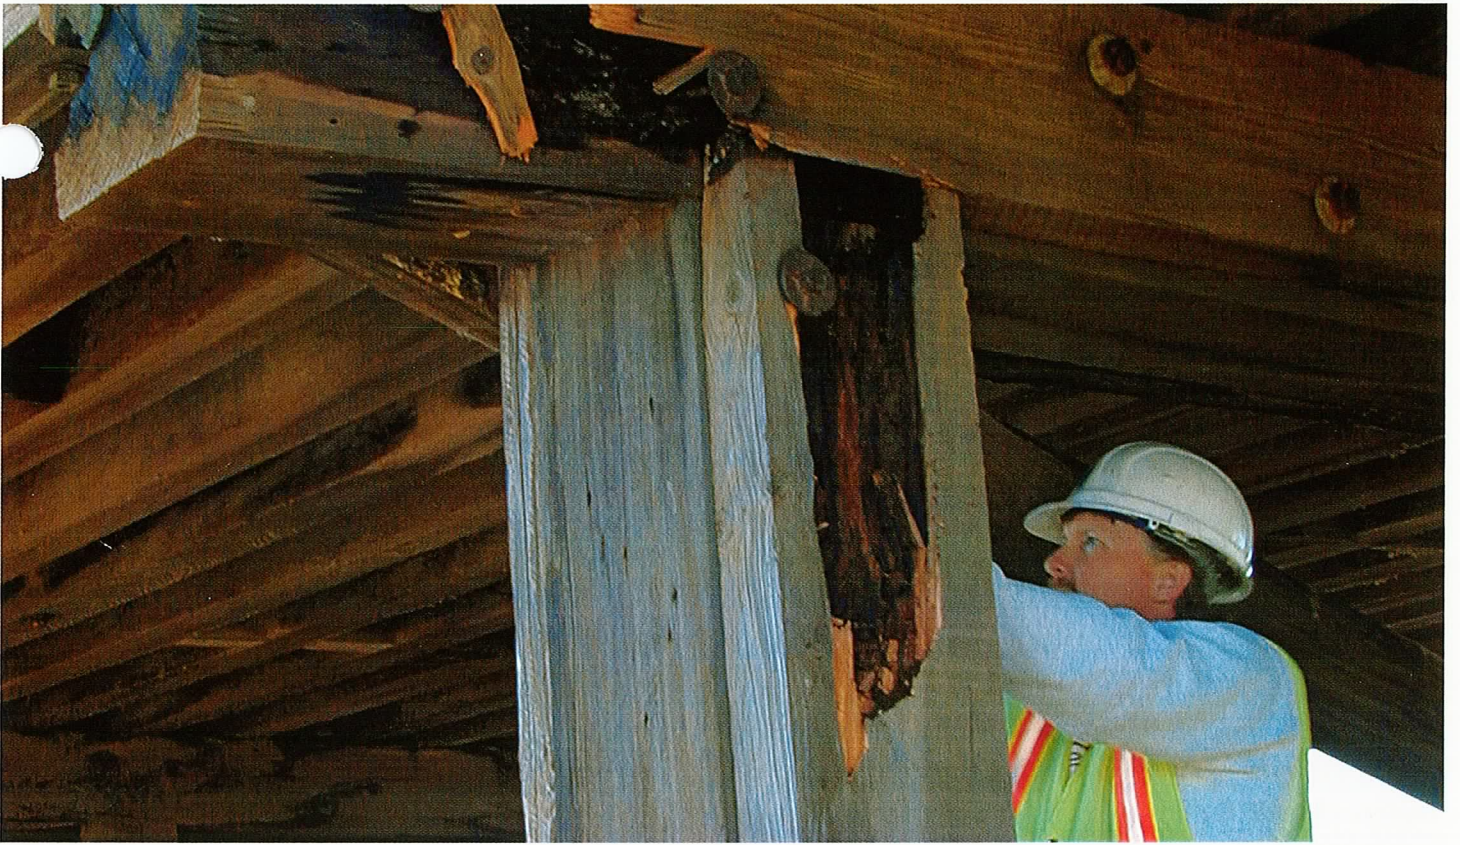
Both sides of bent cap number 10 are fully rotted under stringer lines 1 & 2 and 19 & 20. Stringer number 19 over bent 10 is heavily rotted on the end immediately above the rotted cap. Supplemental sections and supports have rotted and are now ineffective for load carry capacity.

Bent 10 Built-up Section is rotted.
03-SAC-Franklin Blvd, Br#: 24C0155, Mokelumne River Overflow, 02/28/2002, 06B-Dscn0988.jpg

Replace or supplement the rotted timber bent caps at bents 9, 10, 13, 14 and 17.
